**FRENCH RIVER BASIN
DUDLEY, MASSACHUSETTS**

**LOWER MERINO POND DAM
MA 00109**

**PHASE I INSPECTION REPORT
NATIONAL DAM INSPECTION PROGRAM**

OCTOBER 1978

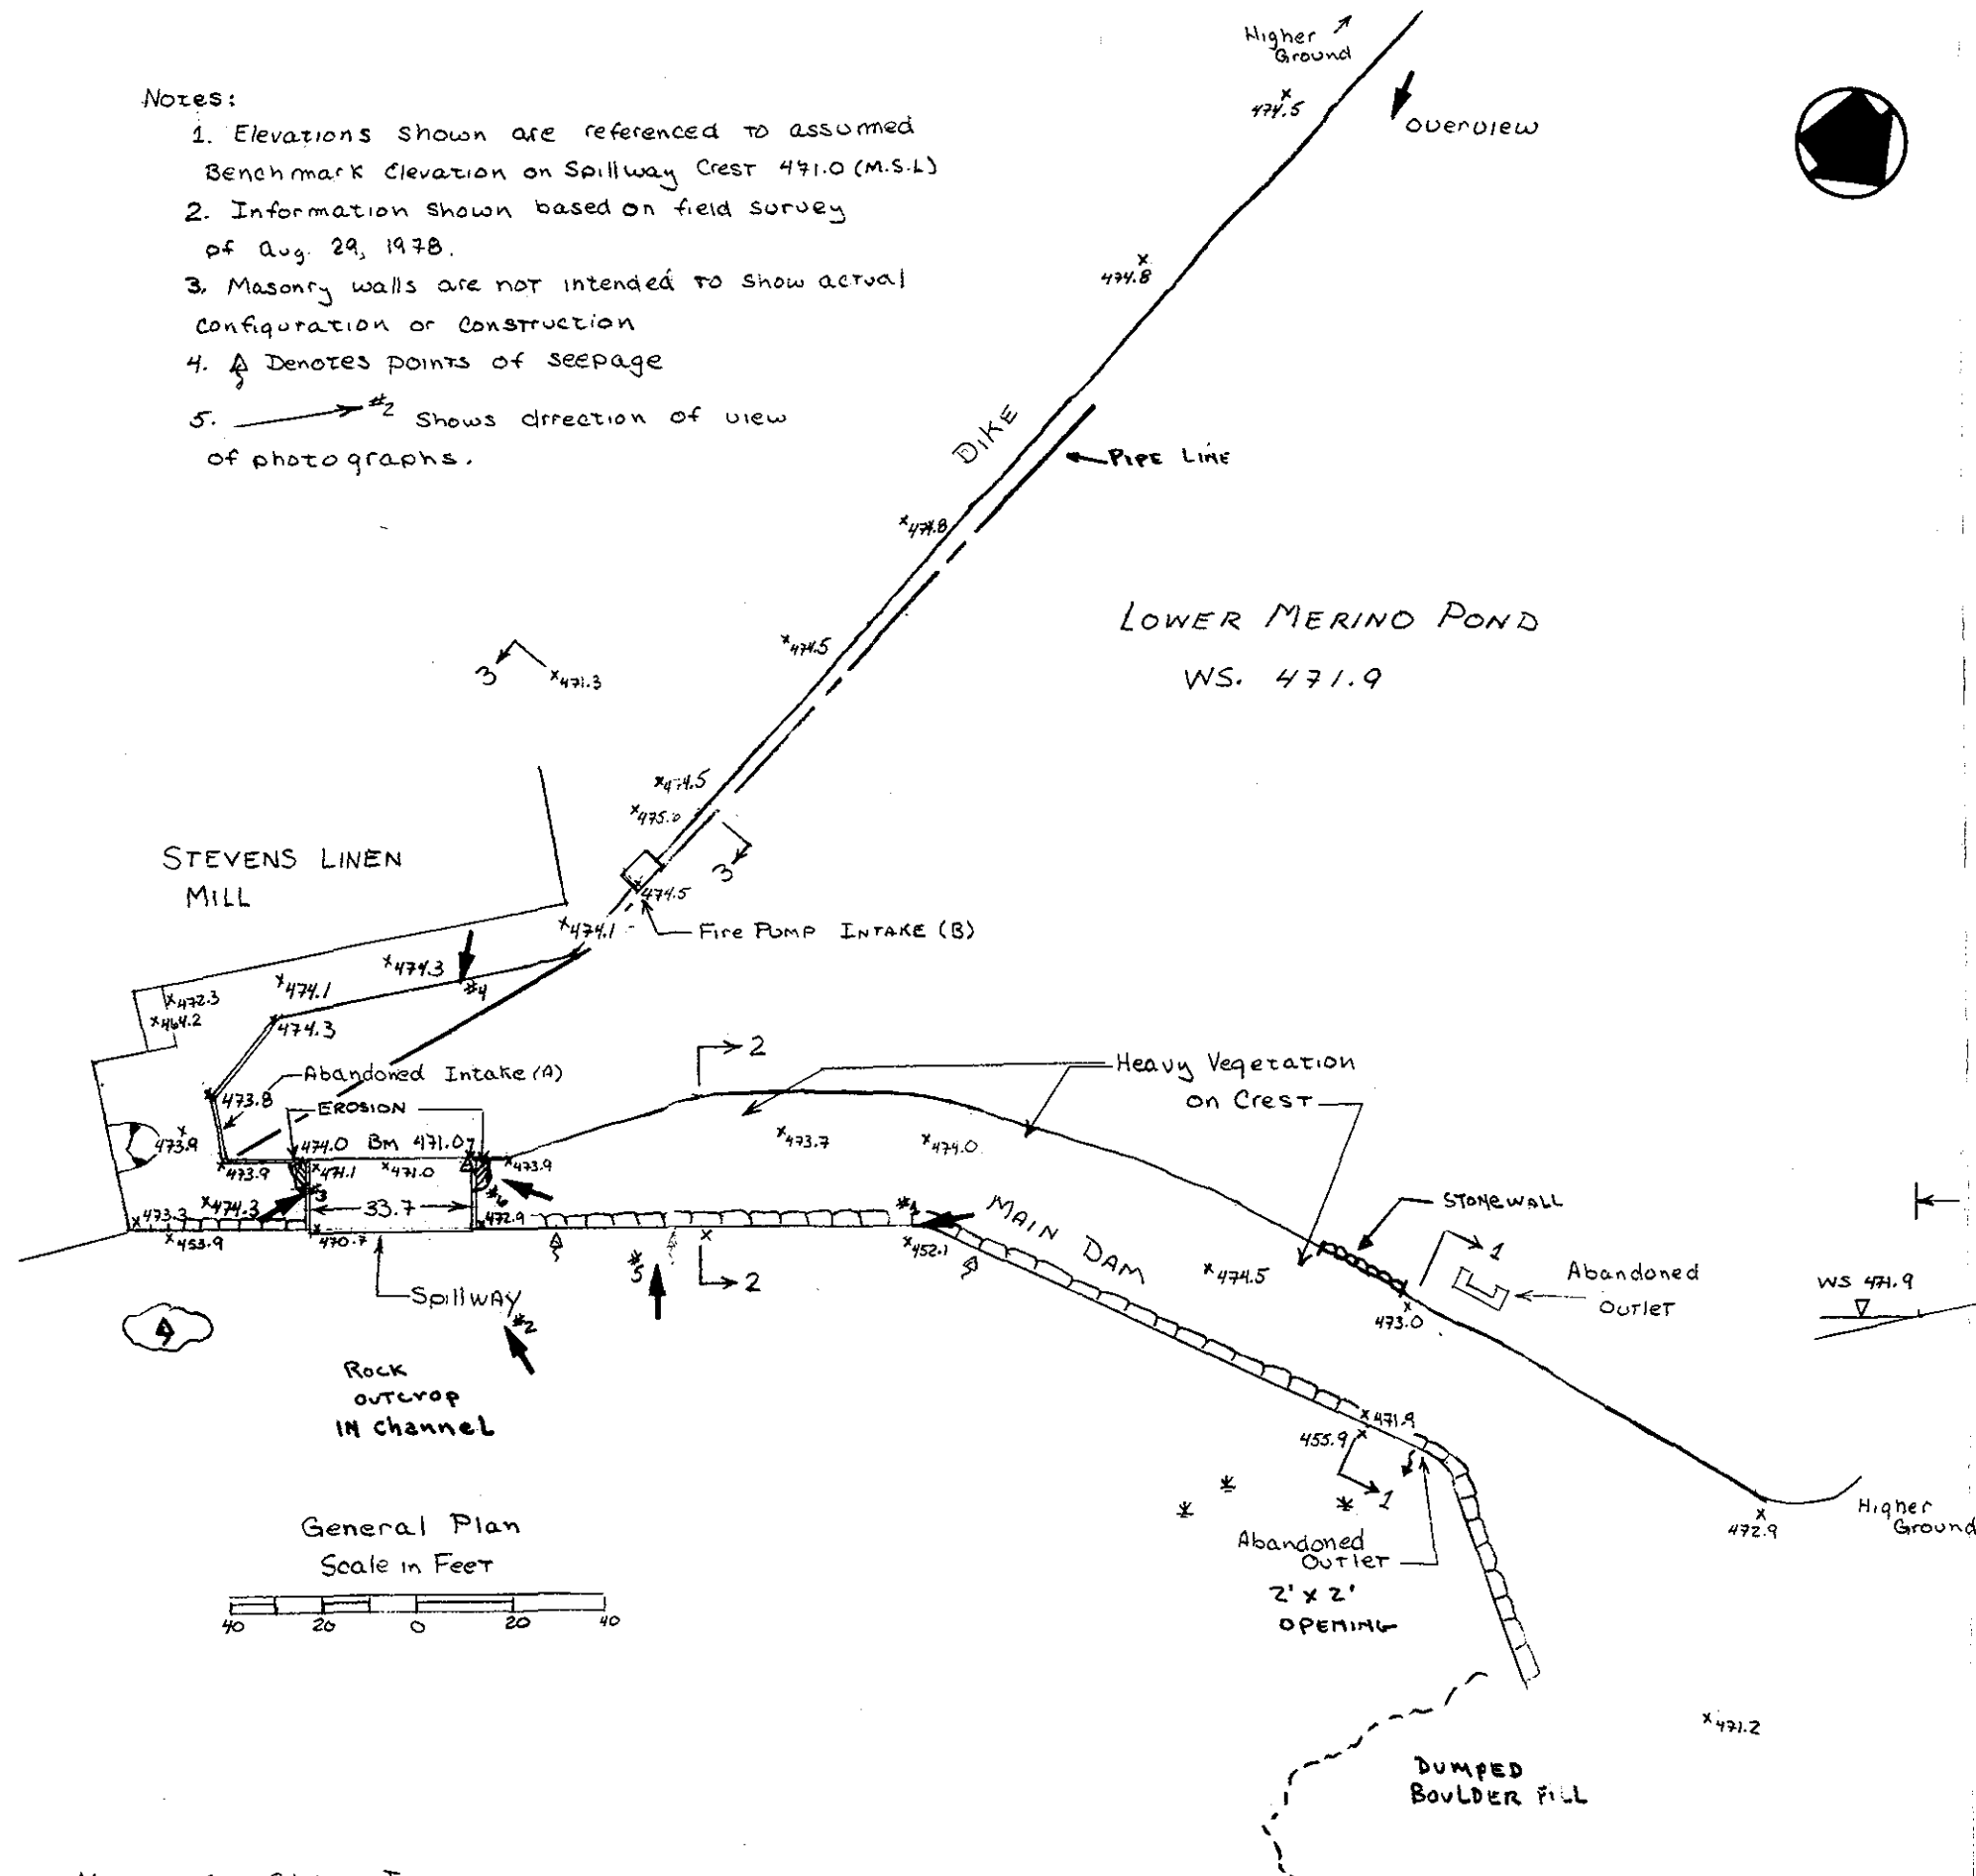
1. Elevations shown are referenced to assumed Benchmark Elevation on Spillway Crest 471.0 (M.S.L.)
2. Information shown based on field survey of Aug. 29, 1978.
3. Masonry walls are not intended to show actual configuration or construction
4. Δ Denotes points of seepage
5. \rightarrow #2 Shows direction of view of photographs.

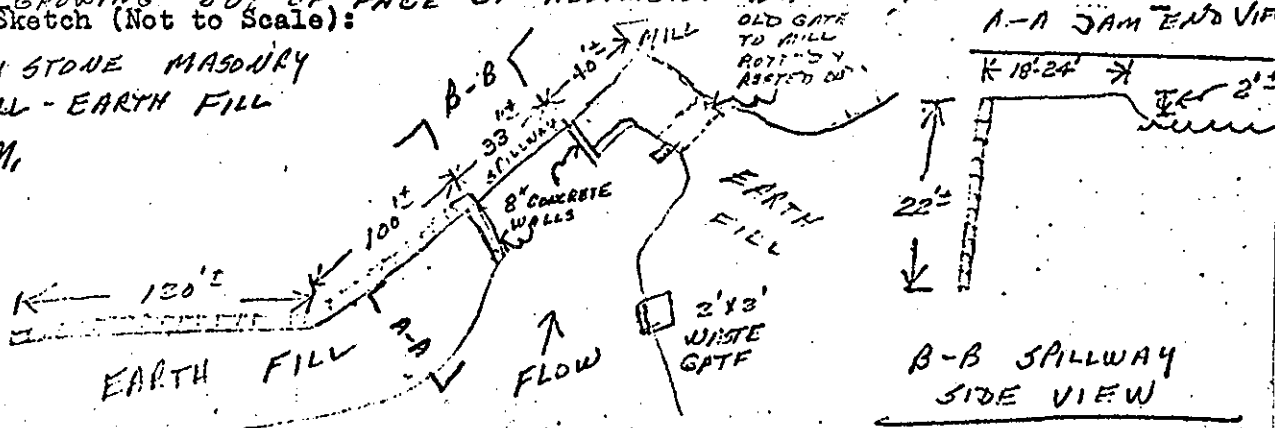
Sketch (Not to Scale):

DRY STONE MASONRY
WALL - EARTH FILL
DAM,

WASHOUT BEHIND WESTERLY WALL
AT SPILLWAY. SHOULD BE WATCHED.
